Sep 11th, 2025

123 Example Ave., Altoona, PA 16601

Home Inspection Report

Brenton Horwood / H & H Property Inspections, LLC

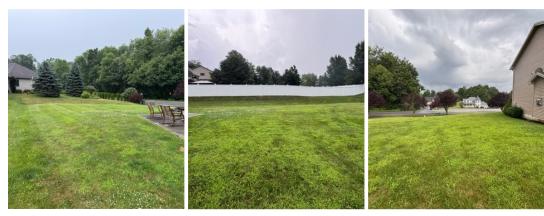
The general grade appears to be properly sloped away from foundation

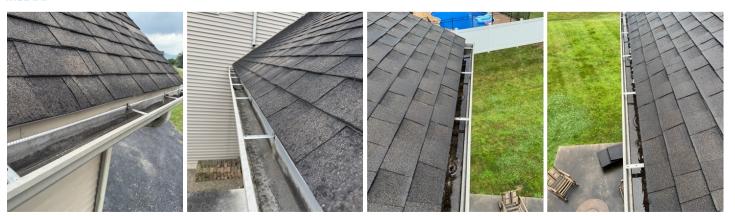
The aluminum gutters are securely fastened and in good condition, with no visible defects or issues noted during the inspection. It is recommended to maintain regular cleaning to prevent debris buildup and ensure proper drainage. Periodically inspect for any changes or potential blockages to sustain optimal functionality.

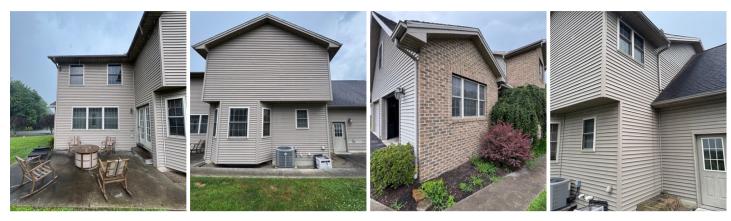
Normal wear and tear.

The property's exterior features a brick facade with vinyl siding on the sides and rear. Some superficial defects and minor wear and tear are present. It's recommended to clean and inspect these areas regularly to prevent further deterioration. Consider addressing any caulking or sealing needs to protect against moisture intrusion. Regular maintenance will help preserve the appearance and longevity of the materials.

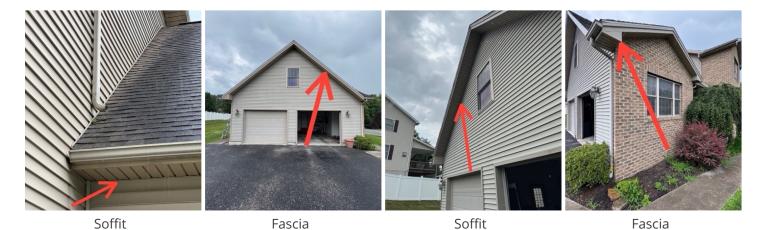
No defects

The property features vinyl soffit and aluminum fascia, which are in good condition with no defects observed during the inspection. However, there is a buildup of dirt that needs attention. It is recommended to clean the soffit and fascia to maintain their appearance and prevent any potential damage from prolonged dirt exposure. Regular cleaning will help preserve the materials and ensure they remain in optimal condition.

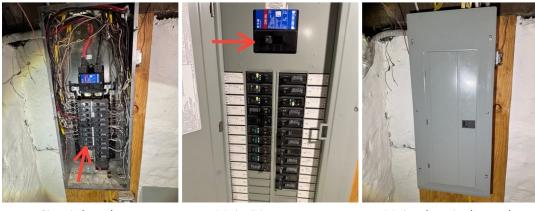
Upon inspection of the electrical main panel, no defects or issues were identified. All components appear to be in good working condition, and wiring is neatly organized. It is recommended to have routine maintenance checks performed by a qualified electrician every 3-5 years to ensure ongoing safety and functionality.

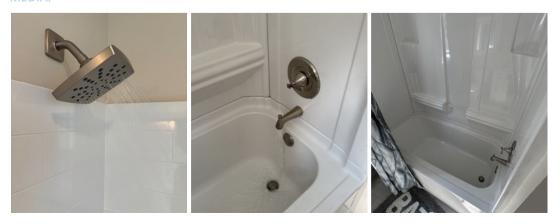
Shower and bath - no defects observed

The shower and bath are in good working condition with no leaks observed during testing. Regular maintenance is recommended to ensure long-term functionality. Consider periodic checks for water quality and caulking integrity to prevent potential future issues.
